Inspection Report Minerals Regulatory Program December 5, 2007

Mine Name: Beck Street Quarry
Operator Name: Lakeview Rock Products, Inc.
Mr. Scott Hughes
900 North Redwood Road
P.O. Box 540700
Salt Lake, UTAH 84054 0700

Permit number: M/035/020
Inspection Date: December 5, 2007
Time: 9:30 AM

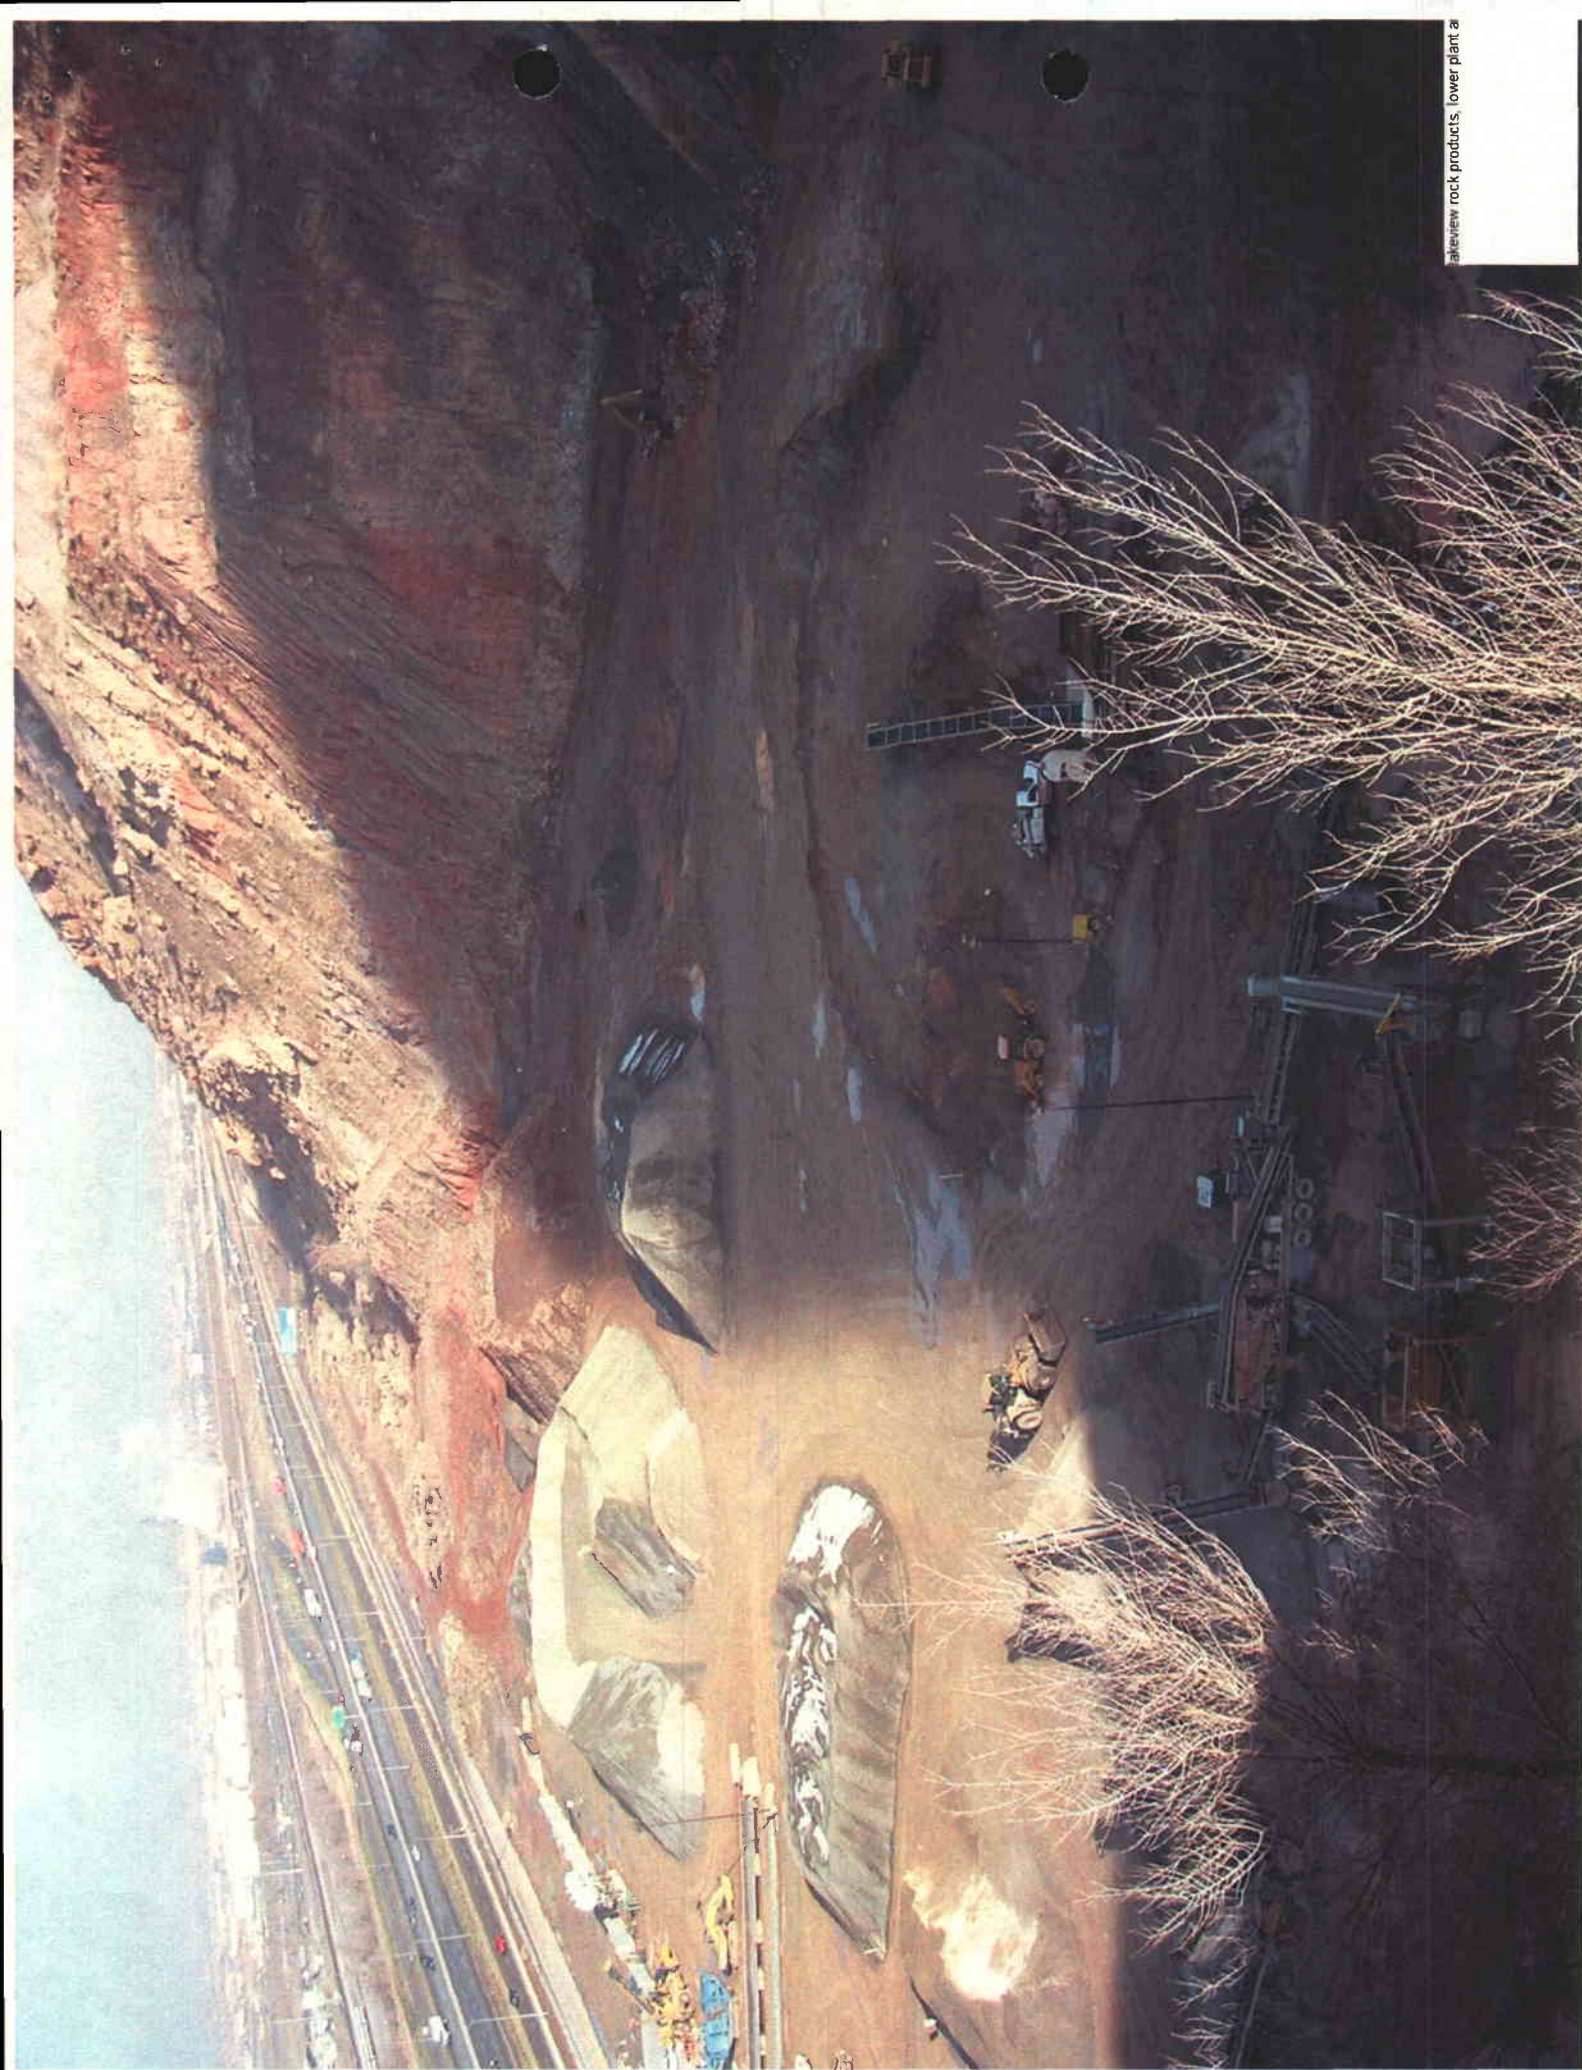
Aerial view rock products, lower plant a

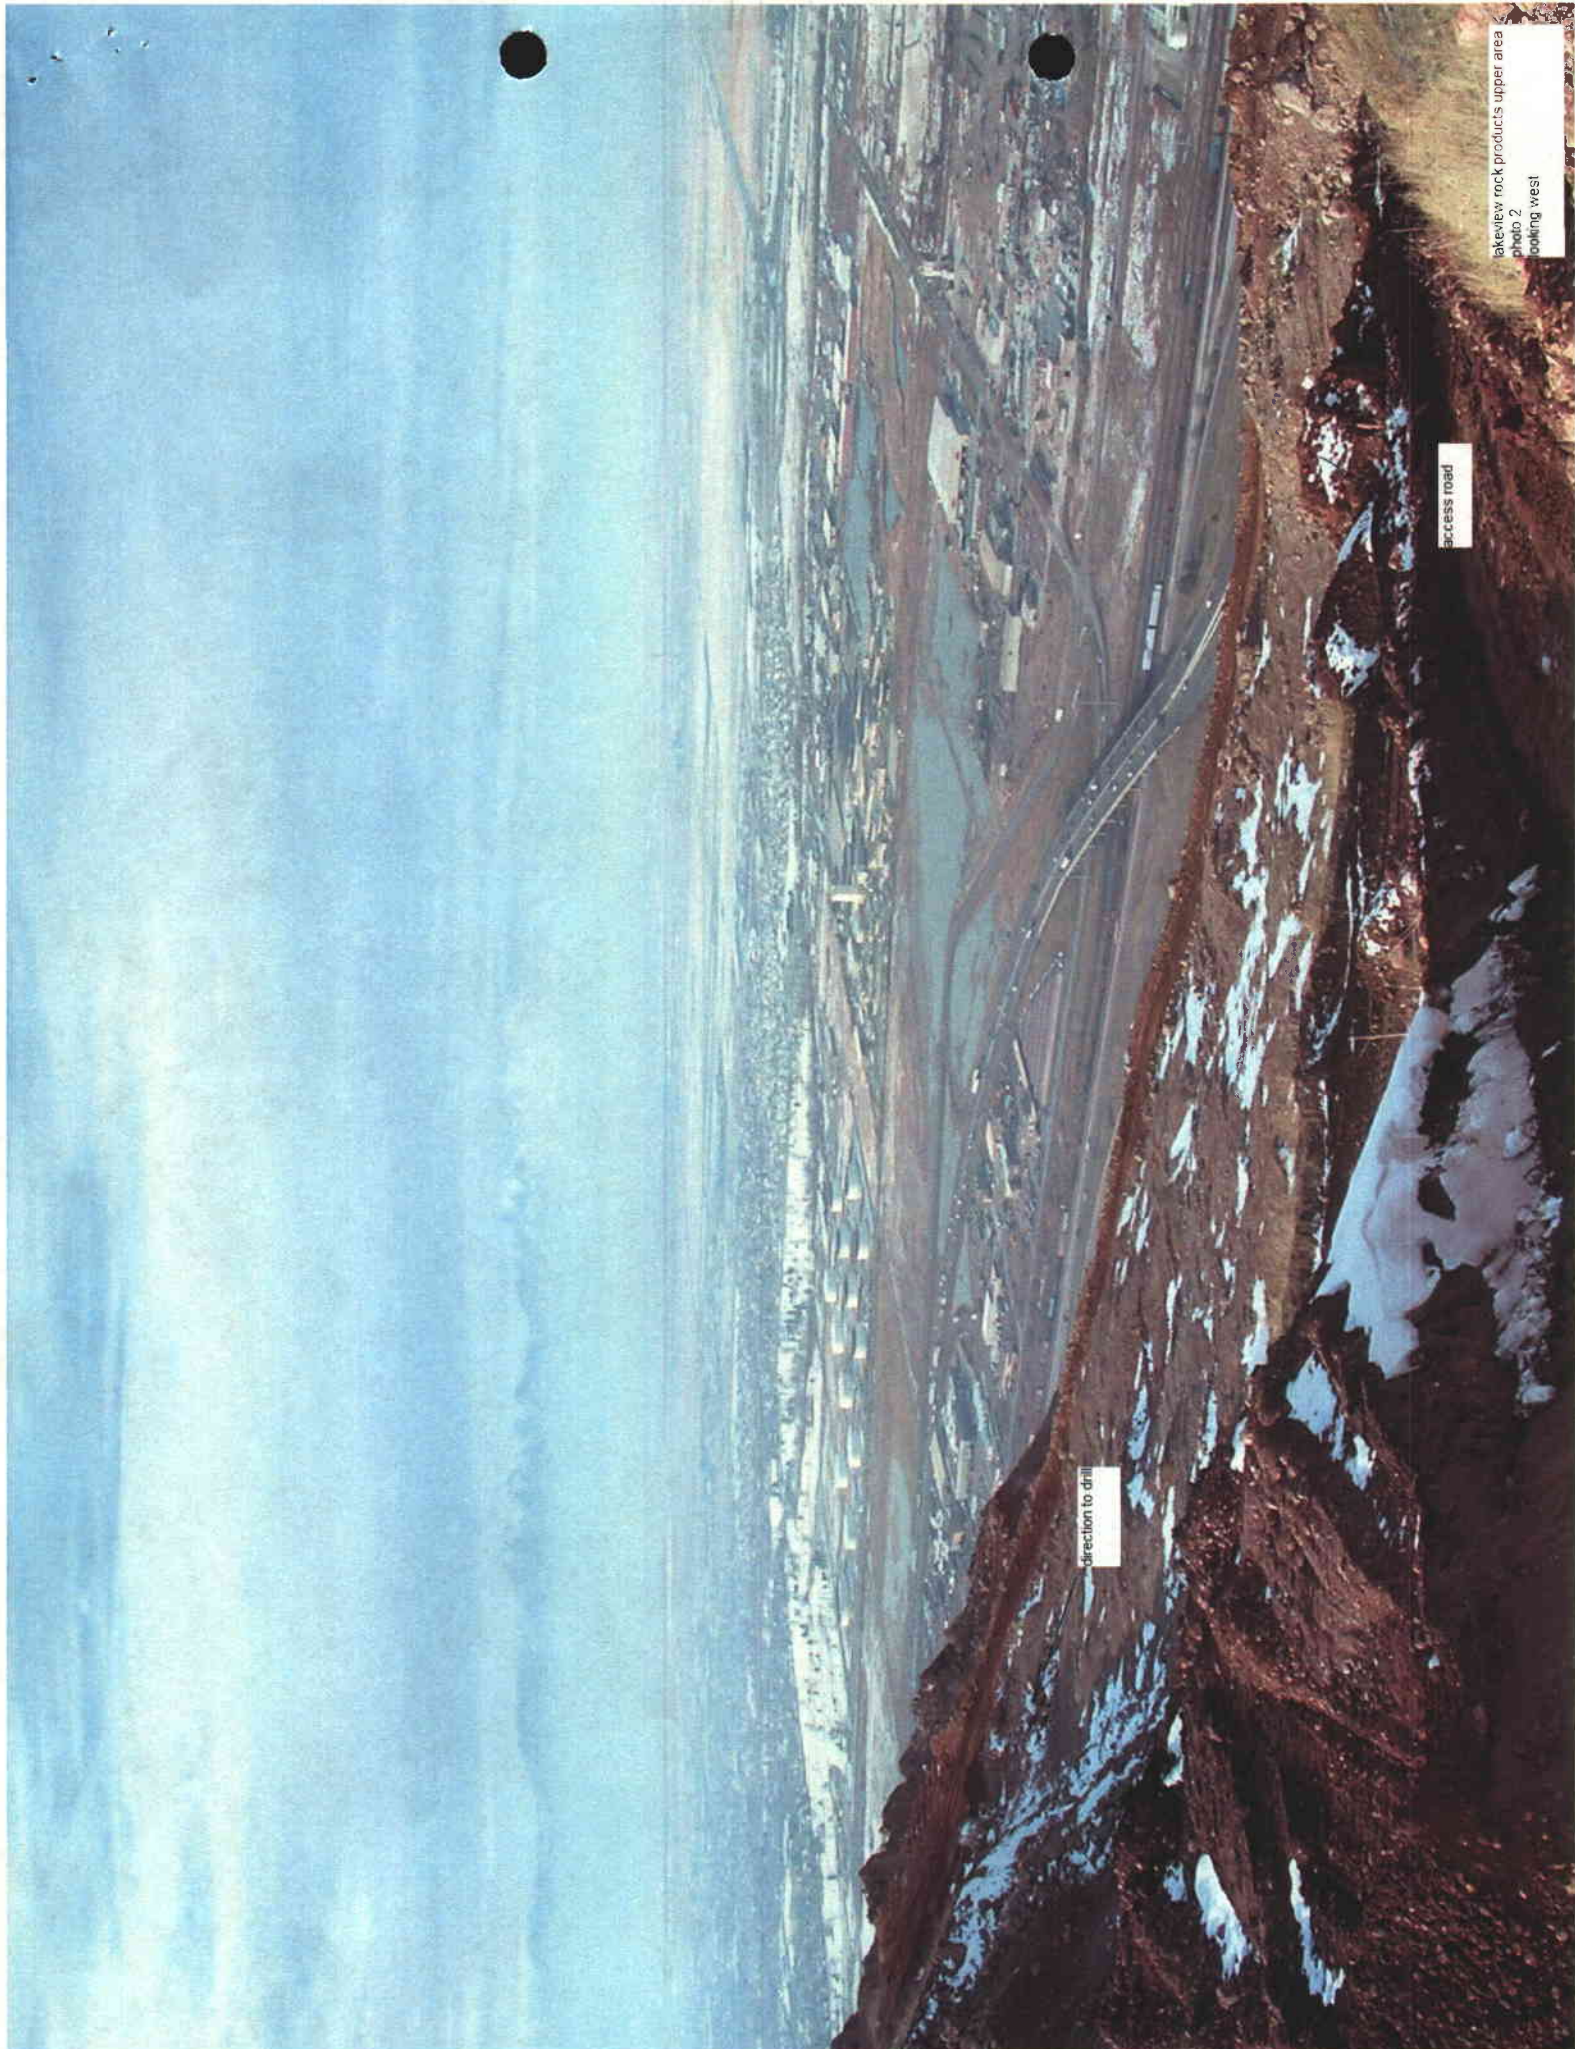
direction to drill

access road

lakeview rock products upper area
photo 2
looking west

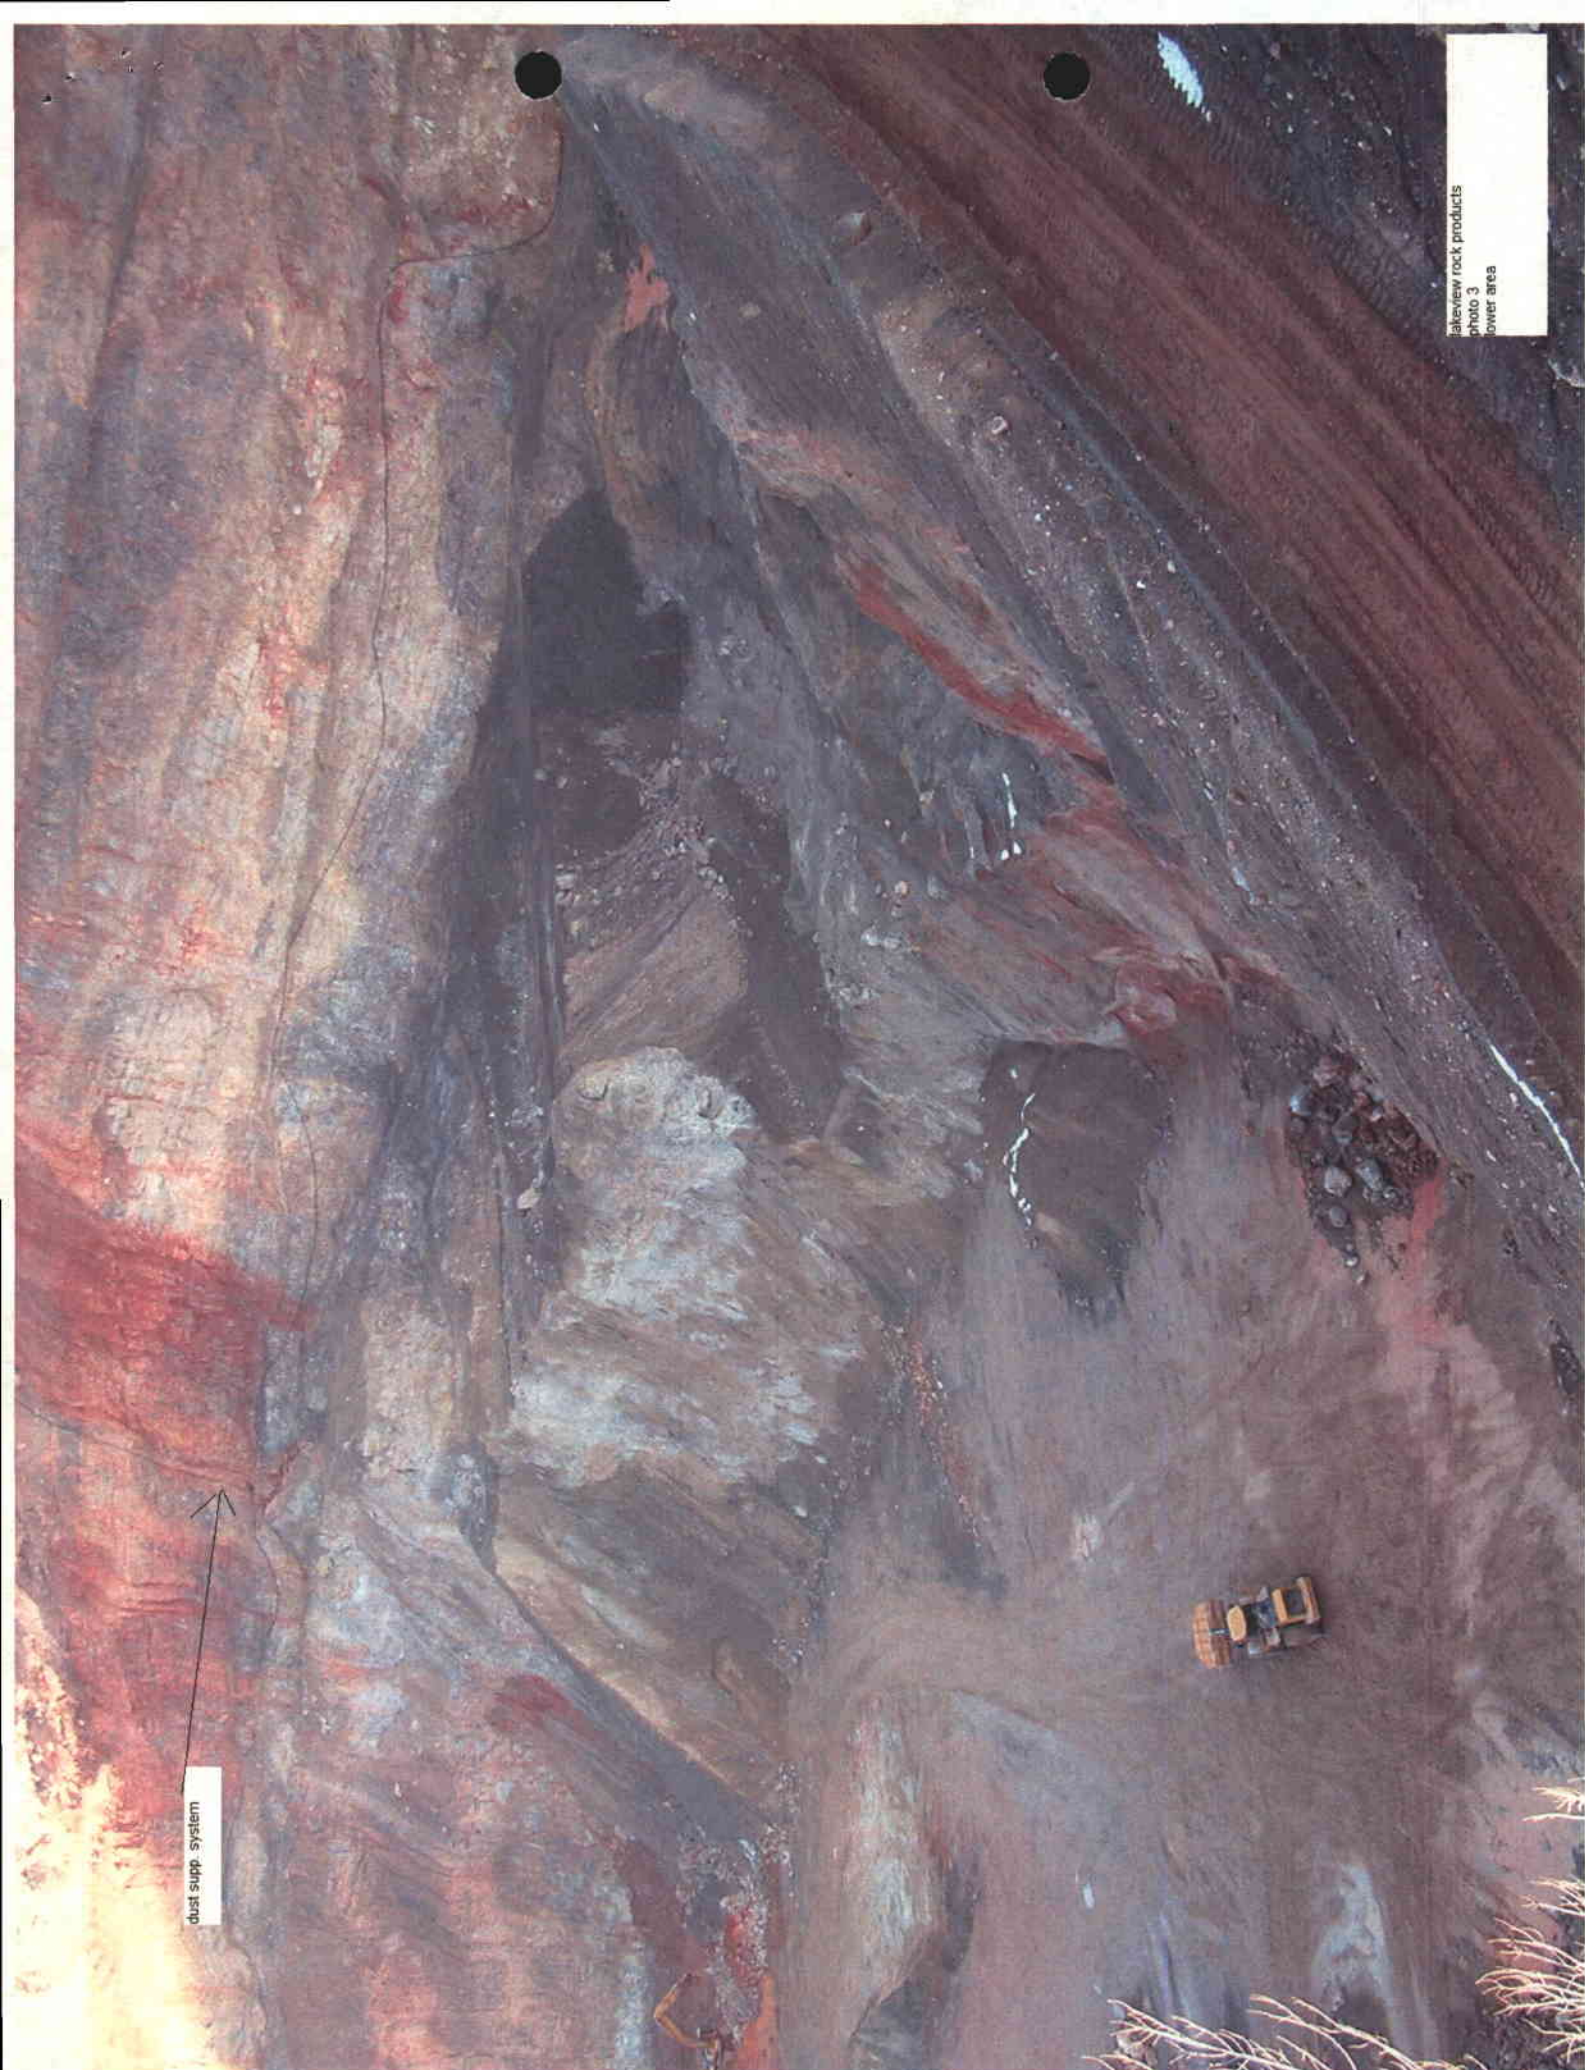
6 – Mr. Burgraff said blasting occurs based on demand, but lately blasting has taken place daily. They installed a new dust suppressant system along the face utilizing extensive piping laid on the surface. The water source is culinary water that is metered at a nearby offsite fire hydrant. Mr. Burgraff said the equipment is fueled and greased each shift at a small maintenance area closer to the Thomas property. He said they do have a night shift of 5-people, and the day shift has 20 employees.

dust supp. system

lakeview rock products
photo 3
lower area

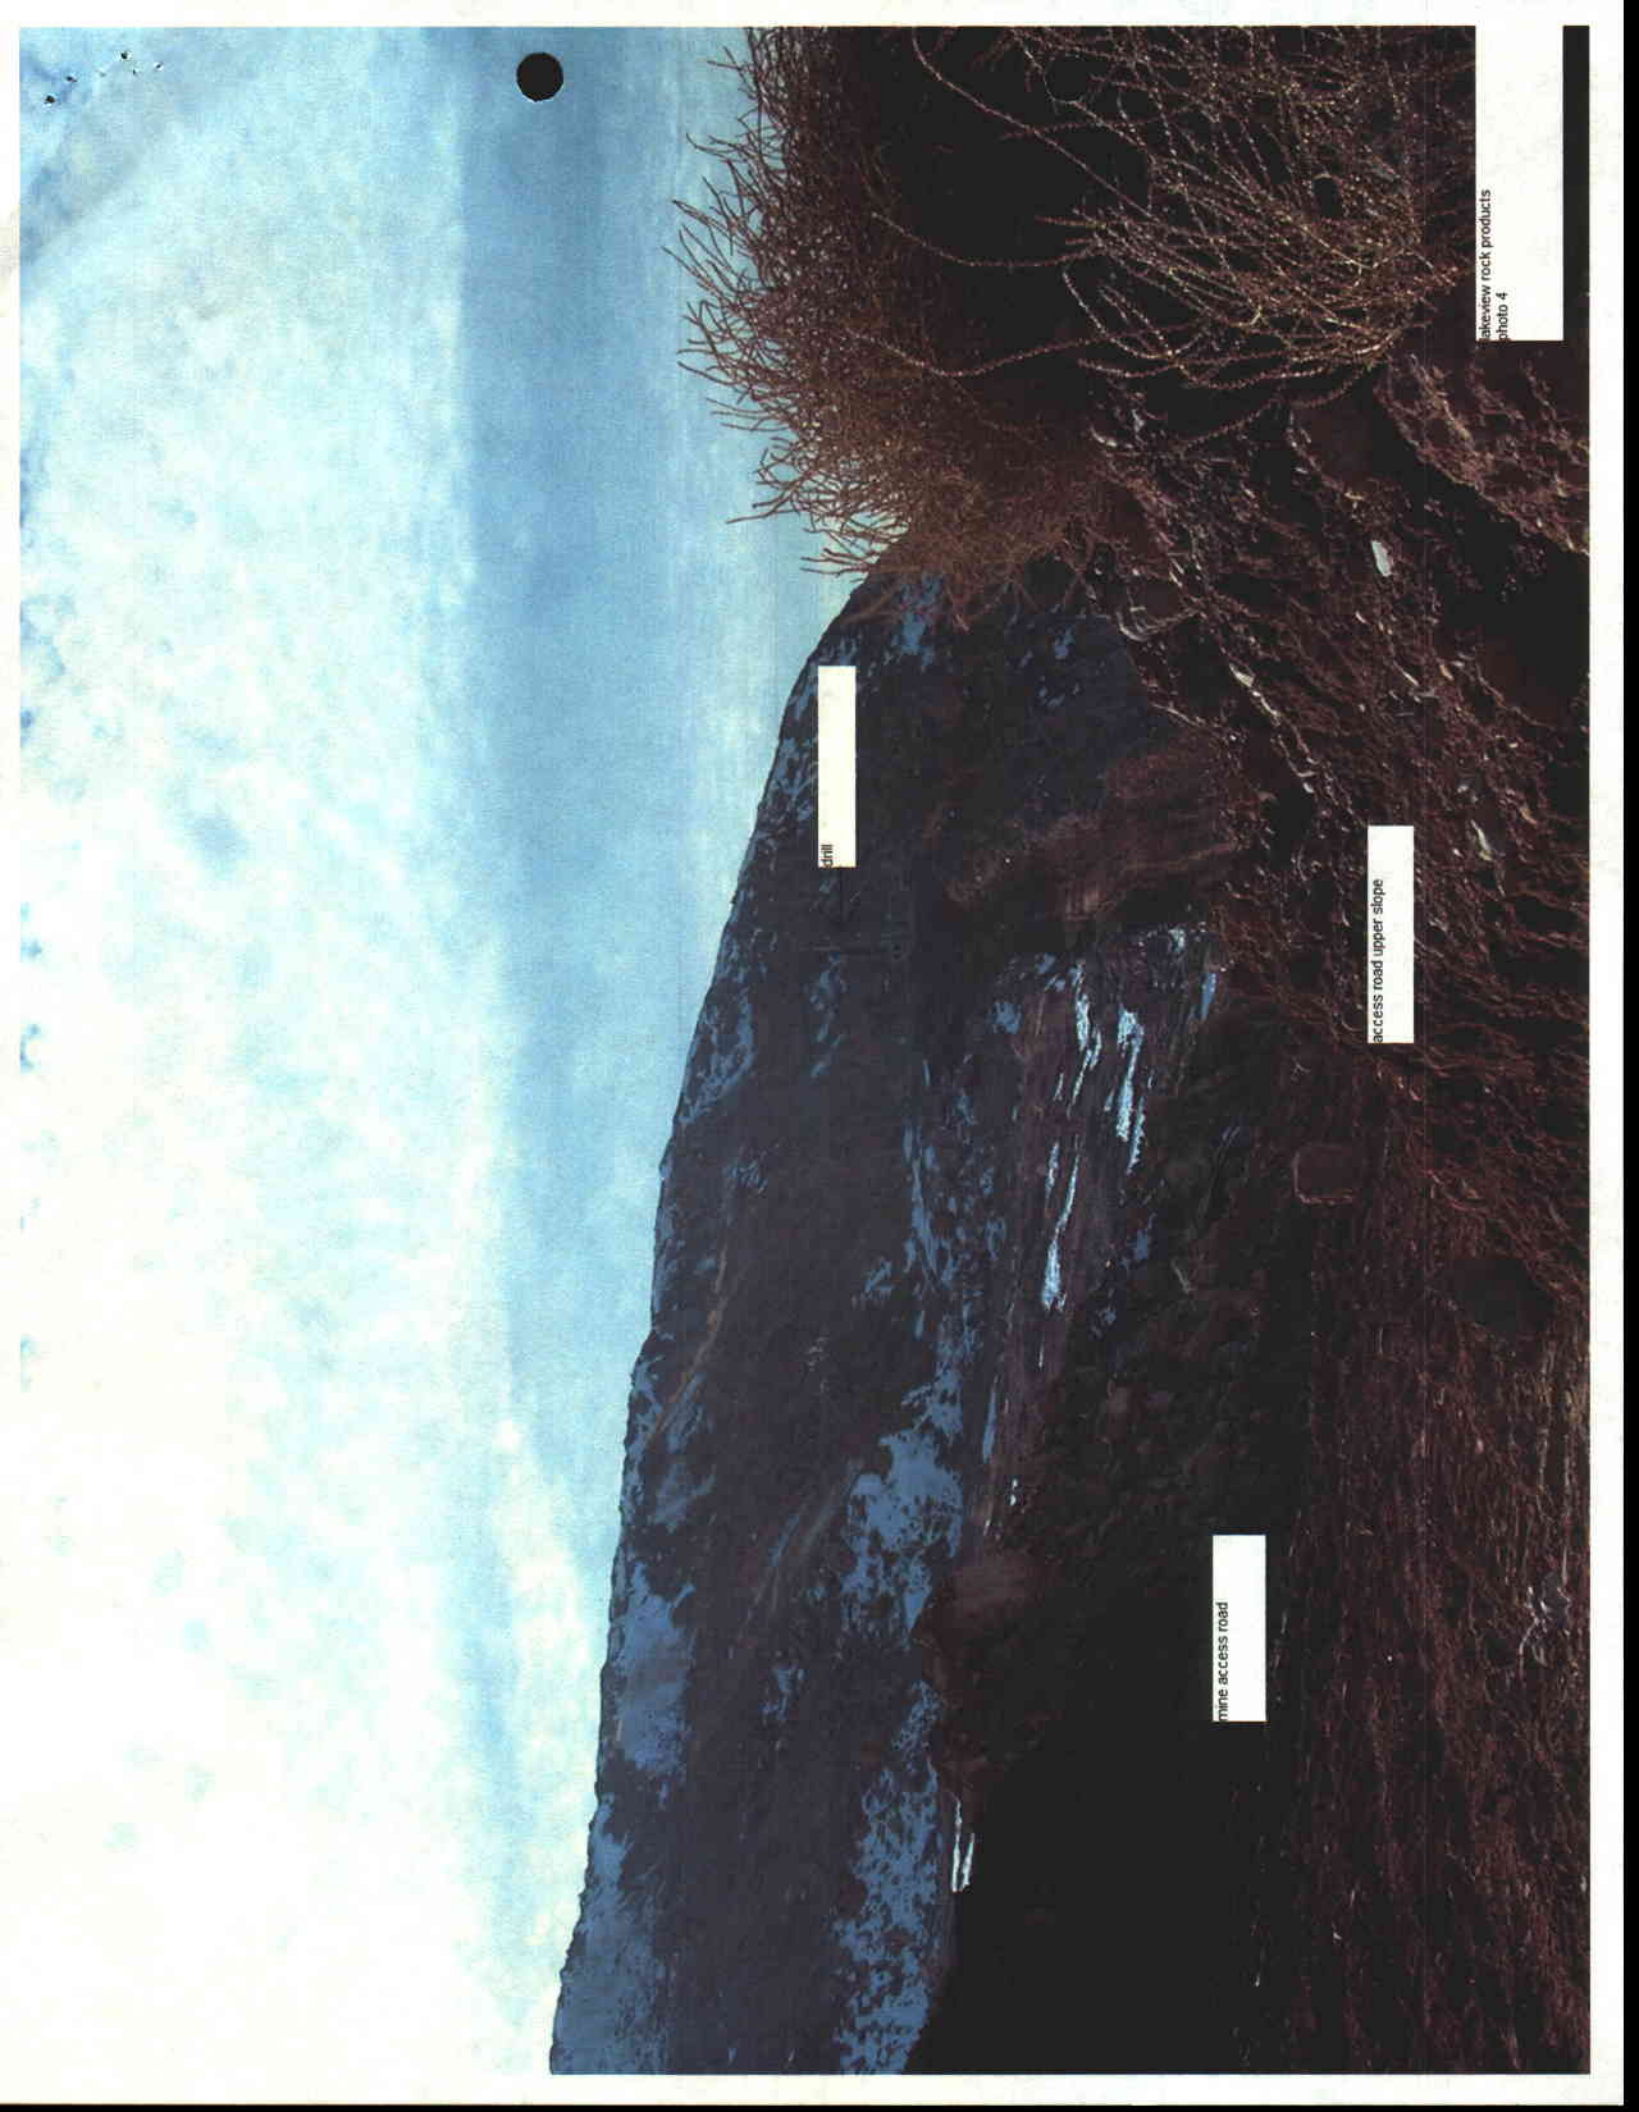
5- The access roads that were viewed or traveled appeared to be well maintained and bermed appropriately. The access roadside steep-upper slopes may be susceptible to erosion and rock falls, and there may be some measures that could be taken to minimize the risk along these travel routes.

lakeview rock products
photo 4

access road upper slope

mine access road

Per paragraph 5 above, it is worthwhile to investigate solutions to the potential erosion and rock fall risk on the access road upper slopes.
